# DETECTION, LOCATION, AND CLASSIFICATION OF SPACE SHUTTLE MAIN ENGINE NOZZLE LEAKS BY TRANSIENT THERMOGRAPHIC INSPECTION

Samuel S. Russell  
Nondestructive Evaluation Team  
NASA Marshall Space Flight Center  
256-544-4411  
sam.russell@msfc.nasa.gov

James L. Walker  
Center for Automation and Robotics  
University of Alabama in Huntsville  
256-890-6578 ext. 207  
walkerj@email.uah.edu

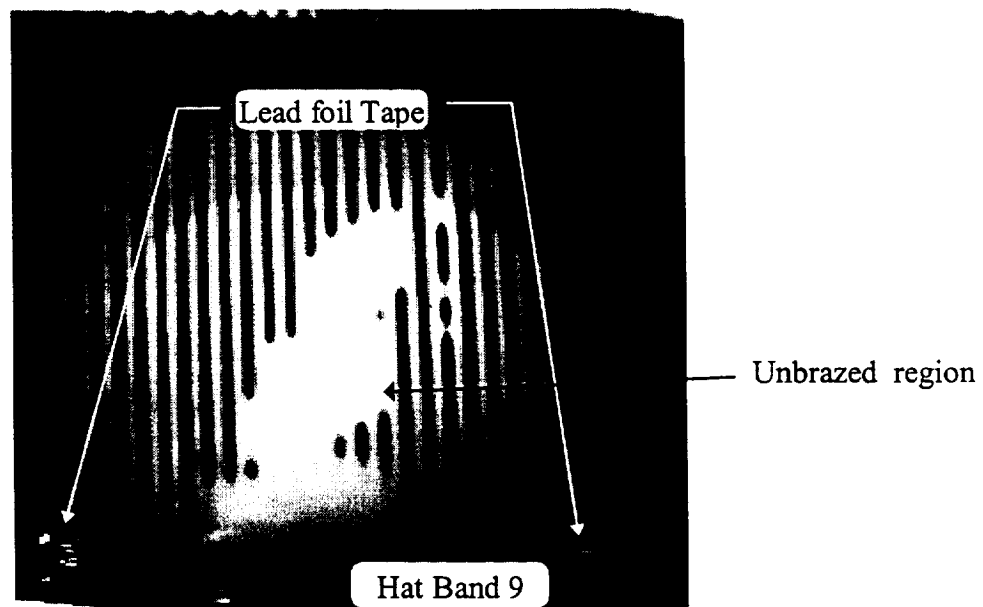
and appear dark in these images. Areas containing discontinuities (such as the programmed defect or the interstitial gaps between the cooling tubes and jacket) did not conduct the heat away from the jacket as well, and appear bright in these images. Figure 3 shows a region of large unbrazed between the tubes and the structural jacket due to a manufacturing defect in a nozzle. However, large regions of the nozzle can not be inspected using Flash Thermography due to the interference of structural stiffeners, insulation, or piping. But, mapping of braze integrity in the open bays is possible.

Figure 3. Flash Thermography of unbrazed area.

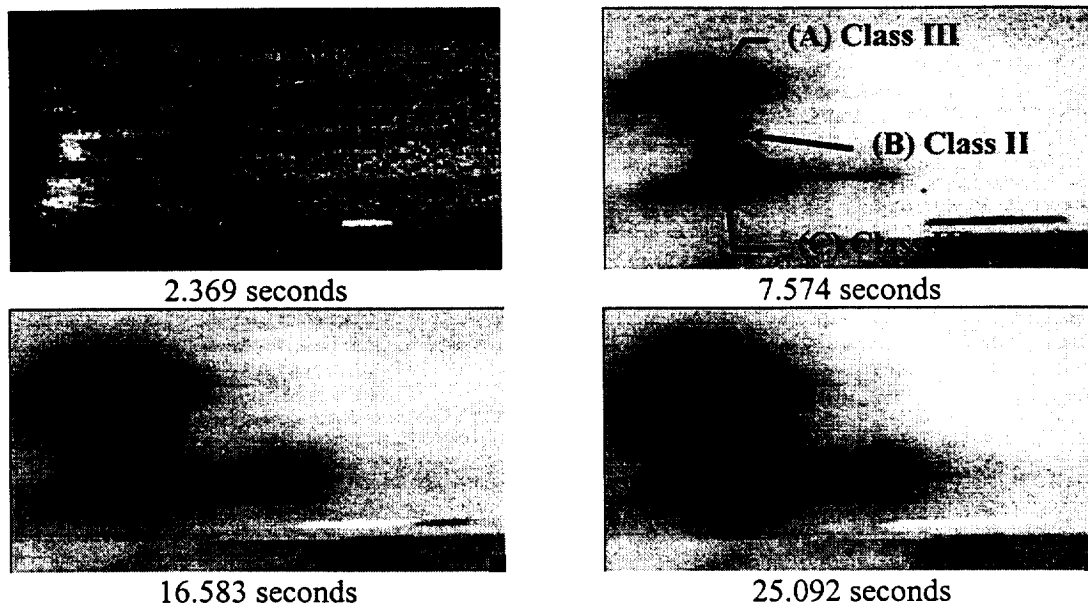
Figure 5 shows the resulting Thermograms over 4 time intervals obtained by rapidly pressurizing the nozzle segment to 40psig (less than 2 seconds to reach maximum pressure) with Nitrogen gas. These Thermograms were made by subtracting an image prior to pressurization from the later images. Hence, the temperature change is accented. Also included (Figure 6) is the Time-Temperature plot for four points on the image which provide an indication of the degree to which the defects can be detected. By re-running the test at several pressure levels, it was determined that the temperature change observed at a leak source increased approximately linearly with increasing pressure. Also, it was determined experimentally that Nitrogen and Argon gas produced larger thermal indications as compared to the Helium gas used for the liquid leak check investigations.

Figure 5. Thermograms of Region 1 of panel shown in Fig. 4.

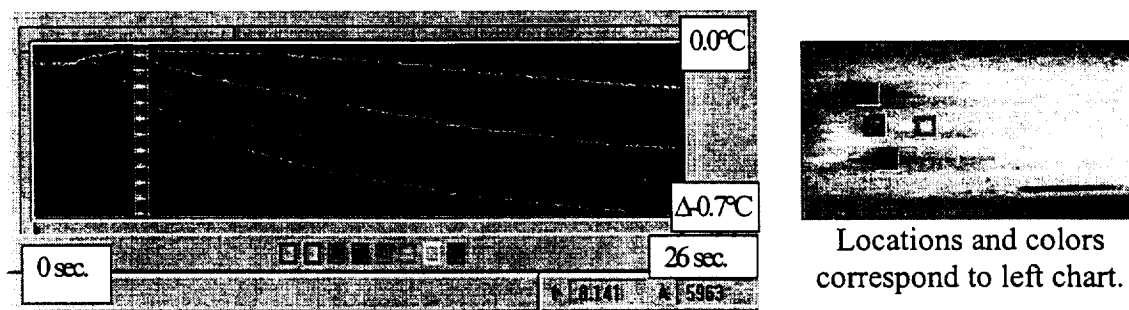
Figure 6. Time vs. Temperature for Class II and Class III leaks in test panel.

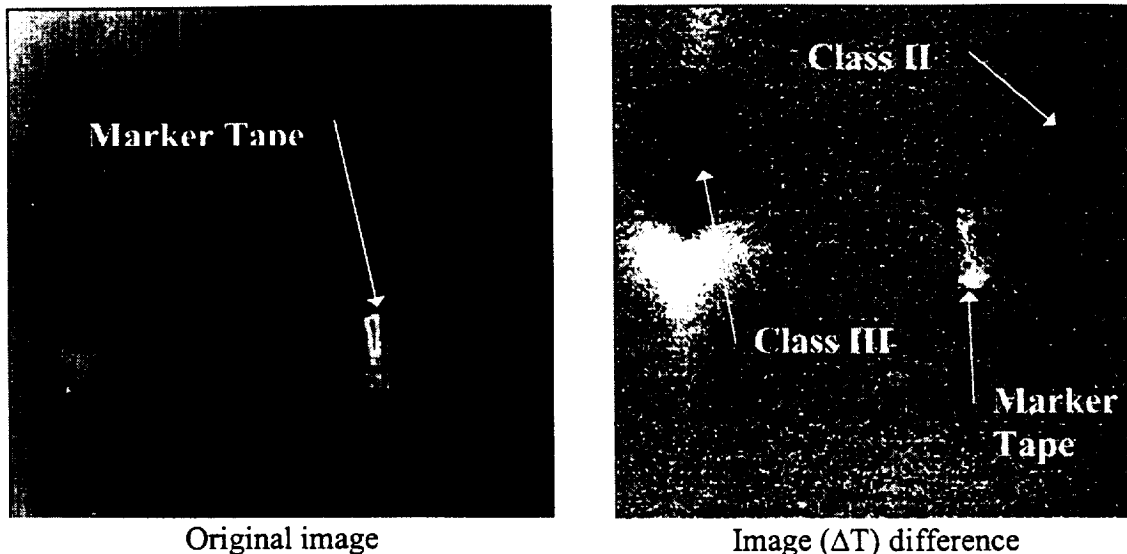
A second panel cut from the upper end of a nozzle was prepared with artificial weld defects that were classified as Class II and Class III as shown in Figure 7. The cooling tubes grow continuously from the top to the bottom of the nozzle creating a somewhat different problem at the top because of the much smaller tubes and interstitials. The Thermograms generated by rapidly (< 2 seconds) pressurizing the segment with 40 psig Nitrogen are shown in Figure 8. The difference between a Class II leak on the right and a Class III on the left is very apparent.

Figure 8. Thermogram of leaks in panel cut from upper portion of nozzle.

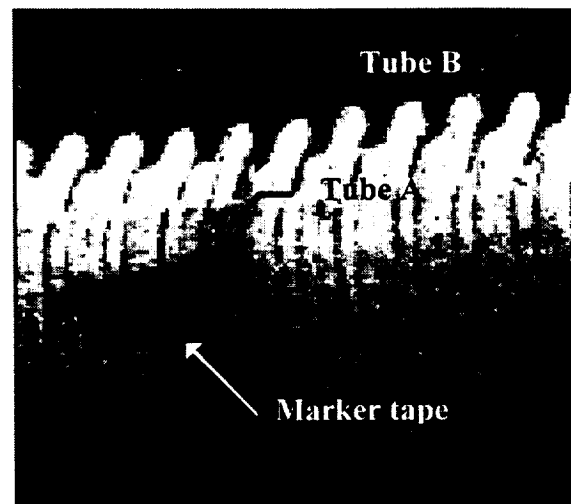
Figure 10. Thermogram of upper edge of nozzle showing leaking tubes.
